SERVICE PROCEDURE

**G-10519
JANUARY 2011**

**SUBJECT: SAFETY RECALL
ENGINE TURBO OIL SUPPLY LINE on certain CE
model school buses built 2/25/10 thru 9/20/10 with
a MaxxForce DT engine**

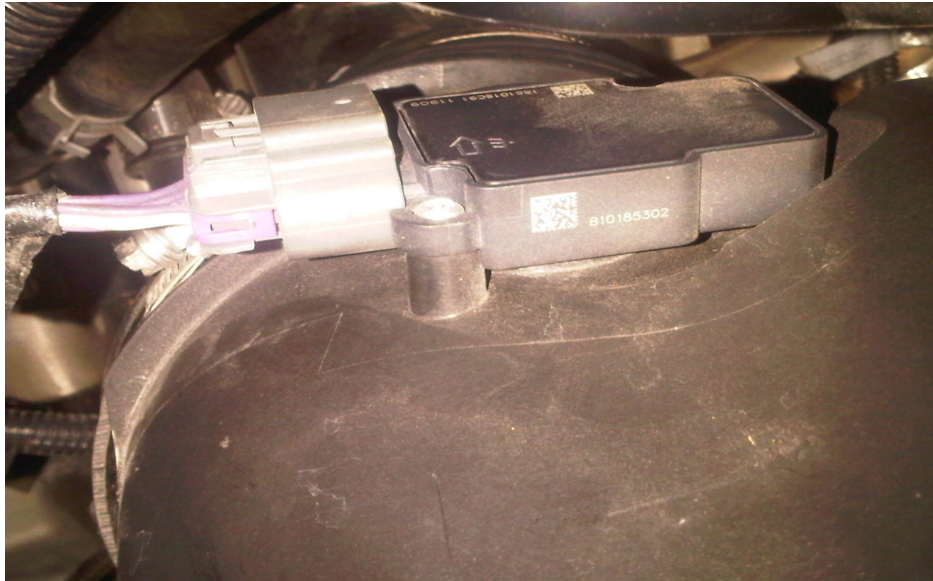
1. Disconnect the MAF sensor connector.

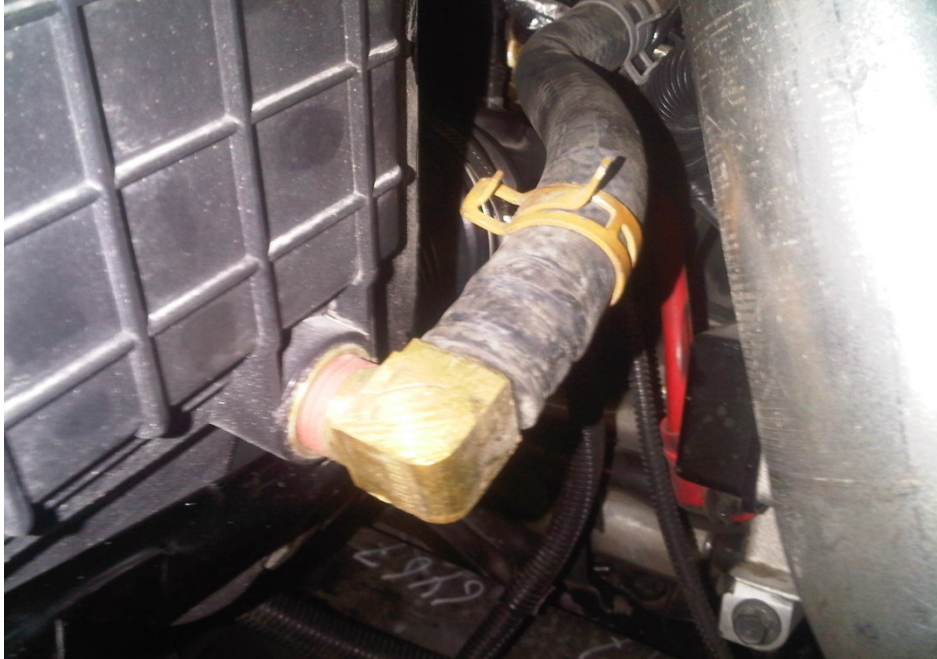
2. Loosen the air box ducting clamps, slide air compressor feed hose clamp to where hose can be removed from 90 degree fitting.

Note: For CE Bus model, removal of the air cleaner is not necessary.

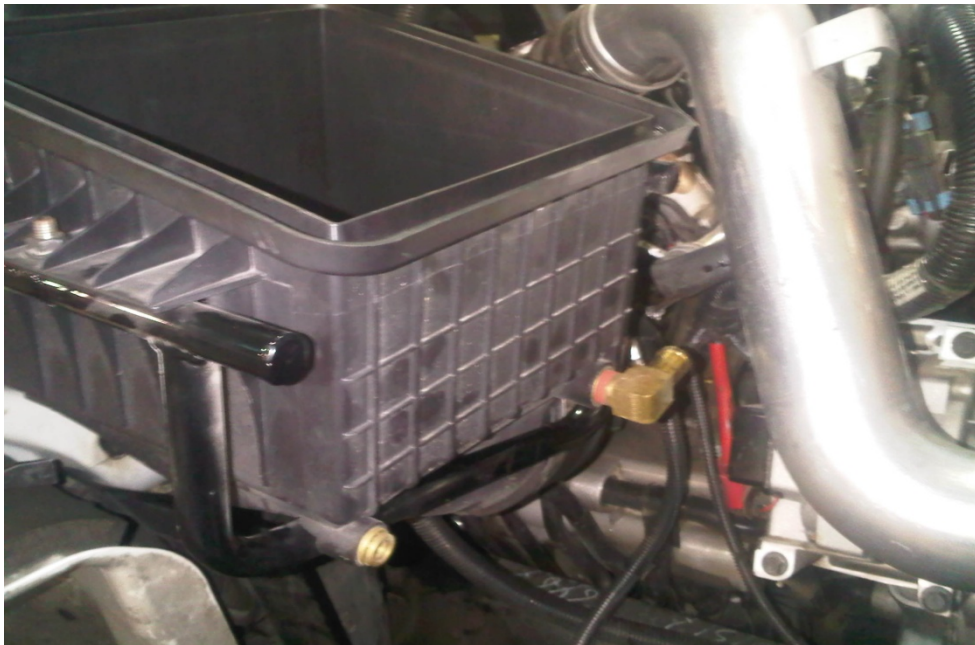
3. Remove retaining nut from air box and remove air box from its frame.

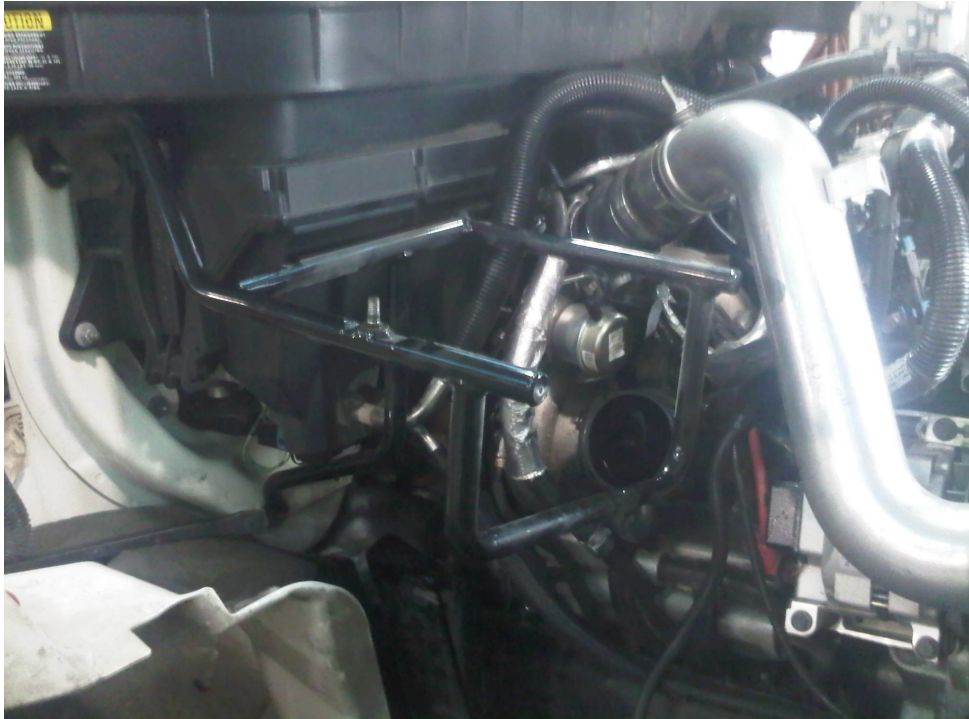
4. Remove the air box mounting frame.

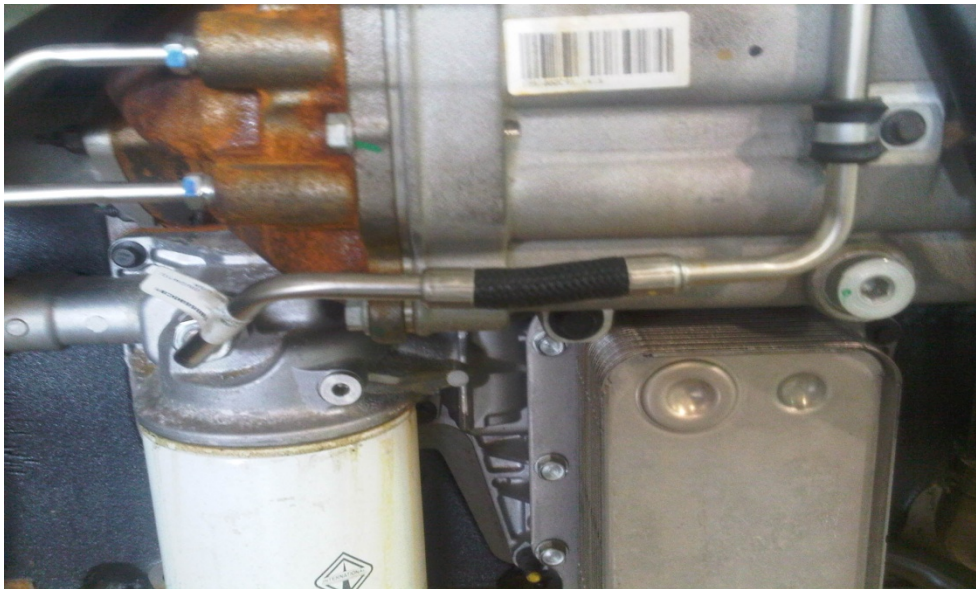
5. Remove the turbo assembly feed line retainers.
6. Remove the oil line clamp located on EGR cooler.
7. Remove the oil supply line from oil filter base.

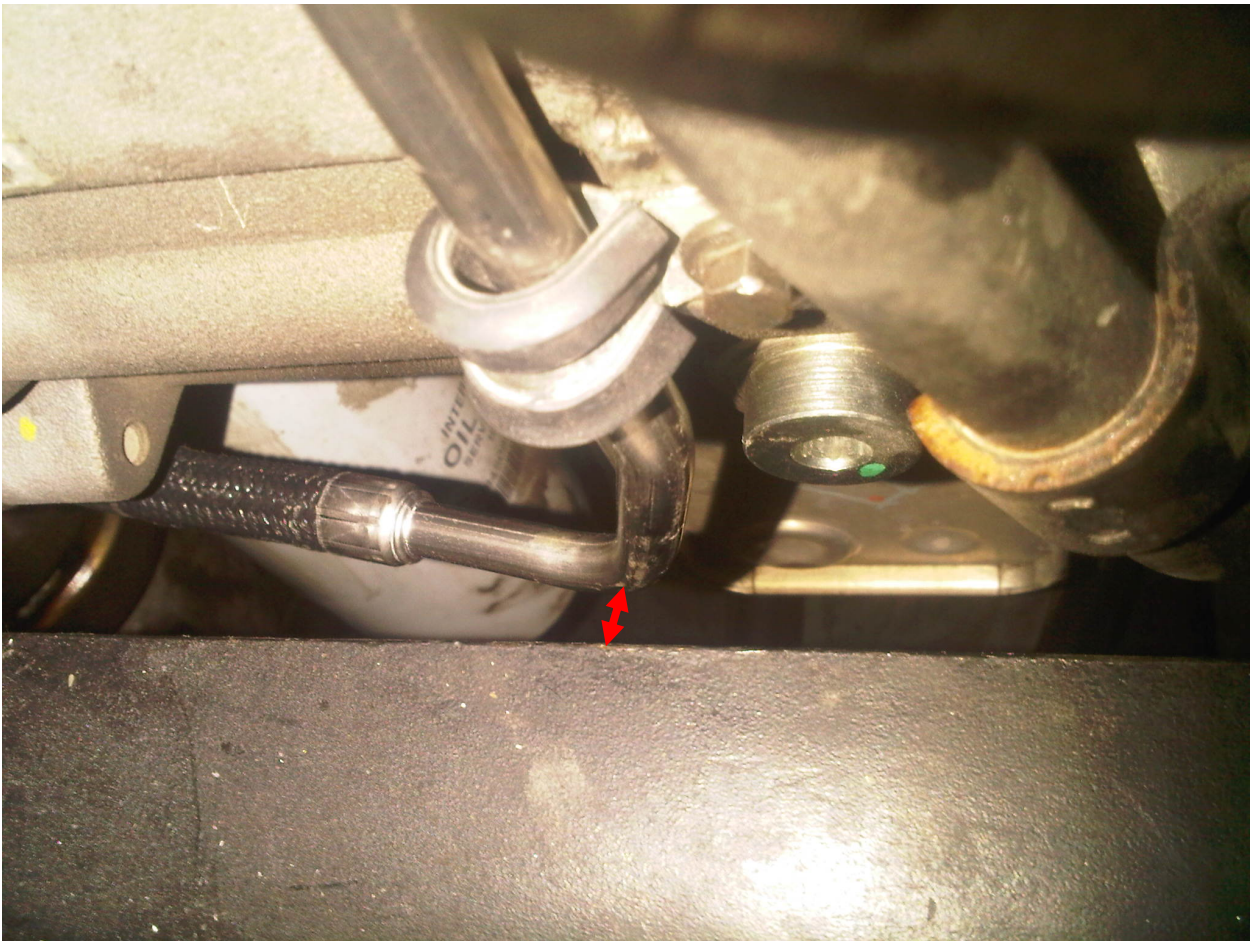
The engine turbo oil supply line may rub on the frame rail possibly causing an oil leak in the engine compartment. An oil leak in the engine compartment may cause a fire possibly resulting in property damage, personal injury, or death.

8. Apply o-ring lube to the new oil supply hose seals.
9. Install the new oil supply line on the turbocharger assembly.
10. Reinstall the oil supply line retaining hardware and torque to 23 lbs. ft.
11. Secure the oil supply line to oil filter base.
12. Reinstall the oil supply line clamp that secures the oil line at EGR cooler.

Note: Ensure that the oil supply line is oriented at least 5mm away from frame rail.

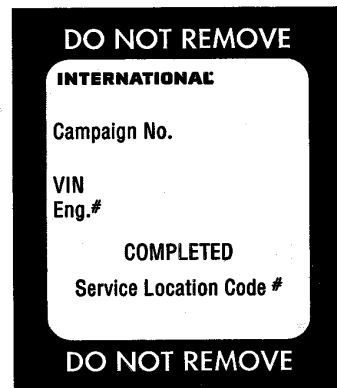
Each vehicle corrected in accordance with this campaign must be marked with a CTS-1075 Campaign Identification Label.

Complete the label and attach on a clean surface next to the vehicle identification number (VIN) plate.
